Sturgeon Lake High-Water Committee Report
December 2019

Introduction

With the water level rising on Sturgeon Lake, a large number of lakeshore owners reported increasing damage to property. The concerns were brought forward at the June 8th, 2019 meeting of the Windemere Township Lakes Association. At that meeting, pursuant to the Association's Bylaws, the board chair authorized an ad hoc committee be established (Sturgeon Lake High Water Committee) to further research the water level issue. This report summarizes that committee's work to date.

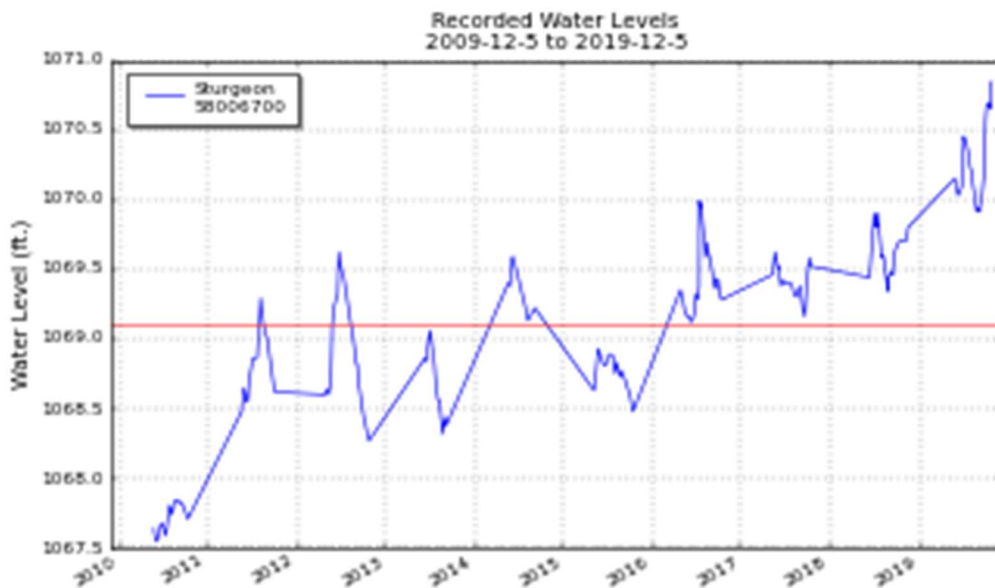
According to the Minnesota Department of Natural Resources (MNDNR), Sturgeon Lake currently has no natural outlet (MNDNR Hydrologist, H. Lindgren, personal communication, October 2019). Consequently, when there are periods of heavier than normal precipitation, other water level stabilizing processes such as evaporation are not sufficient to eliminate excess water and the lake level rises. While acknowledging the reality of lake level fluctuations, the level of Sturgeon Lake is at a historical level. A recording of the lake level taken by the DNR on October 25, 2019 indicated the highest level the lake has ever been since records started in 1945. The level recorded was at 1070.84 feet. That places the level 4.77 feet above the record low of 1066.07 recorded in September of 1977 (Department of Natural Resources, 2019). The surface area of the lake has increased hundreds of acres to its current 1,700-acre size. According to DNR records, Sturgeon Lake has risen approximately 3.3 feet in the last ten years with 2.3 feet of that increase in the past four years.

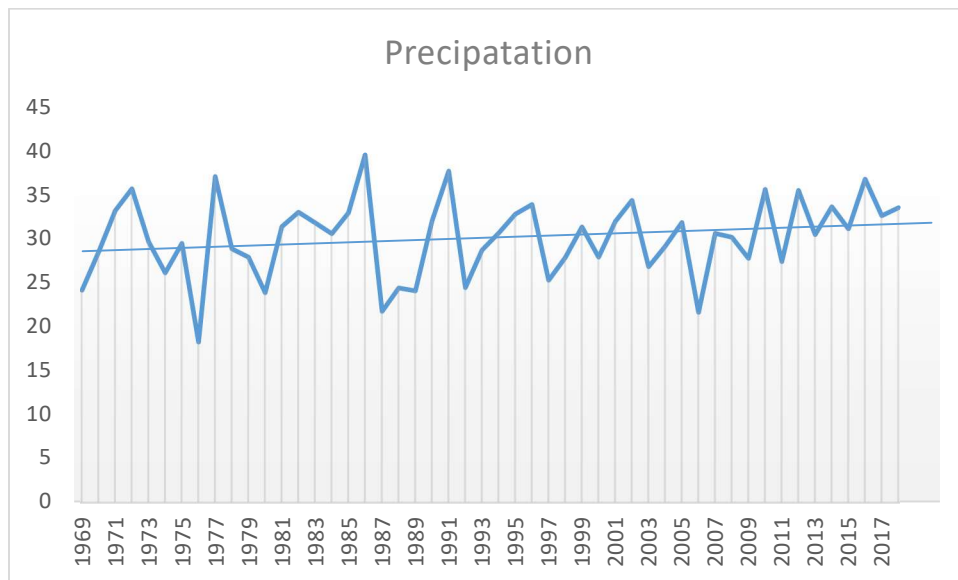
Minnesota Department of Natural Resources (MNDNR, 2019) records indicate that there was a significant increase in precipitation from the late 1960's through 1972. Published data from the MNDNR indicates that precipitation in the Sturgeon Lake area in 1968 of 41.26 inches and in 1972 of 35.73 inches are the top two precipitation years since 1895, likely contributing to the high-water issues in 1973-1974. Conversely, the precipitation amount in 1976 of 18.28 was the second lowest since 1895, likely leading to the abandonment of high-water mitigation projects. As pointed out by the MNDNR, these fluctuations in precipitation influence the water level of Sturgeon Lake. However, in reviewing a 30-year precipitation chart for the Sturgeon Lake area, note that the long-term trend has been for an annual average increase in precipitation (MNDNR). Regardless of causation, the data indicates climate change and, although there may be years of brief precipitation relief, the trend is for a continued annual precipitation increase and therefore continued pressure on the water level of Sturgeon Lake (University of Minnesota, 2007).

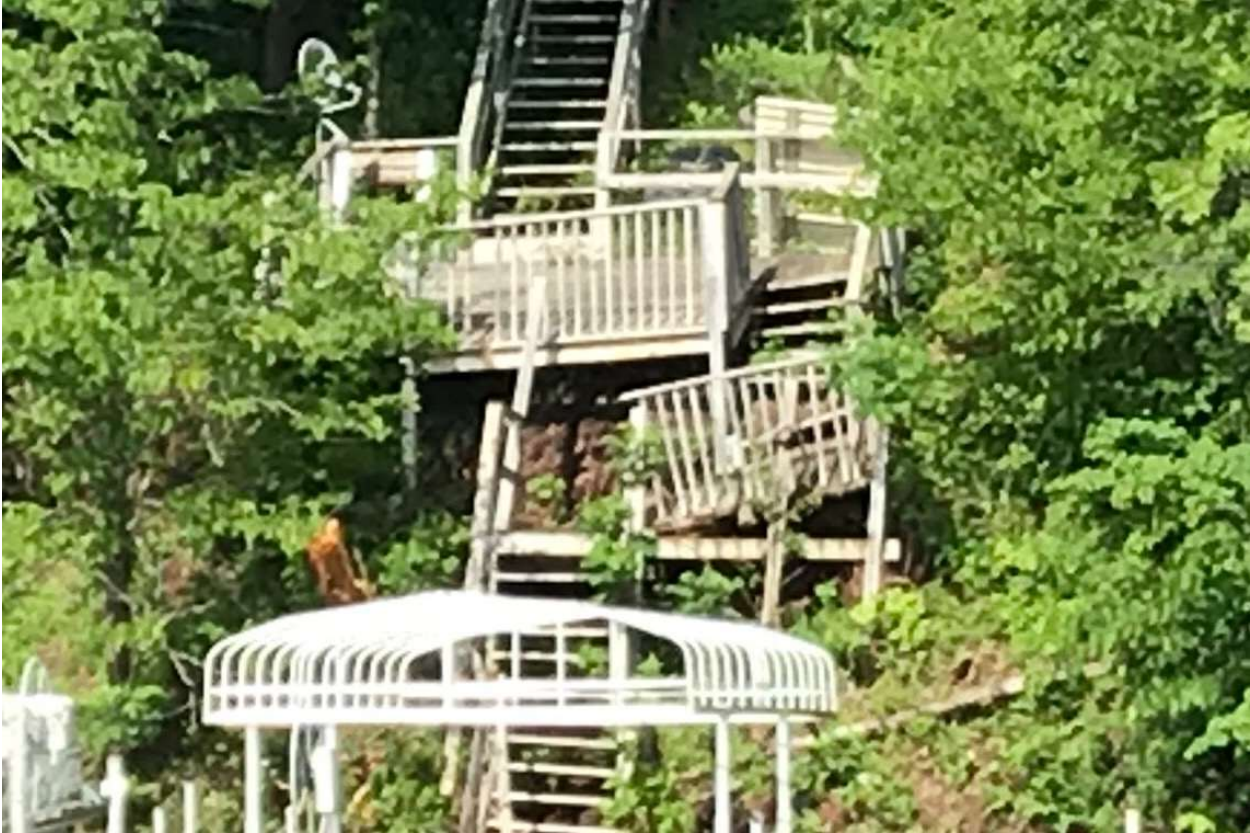
Appendix D

Bank Erosion

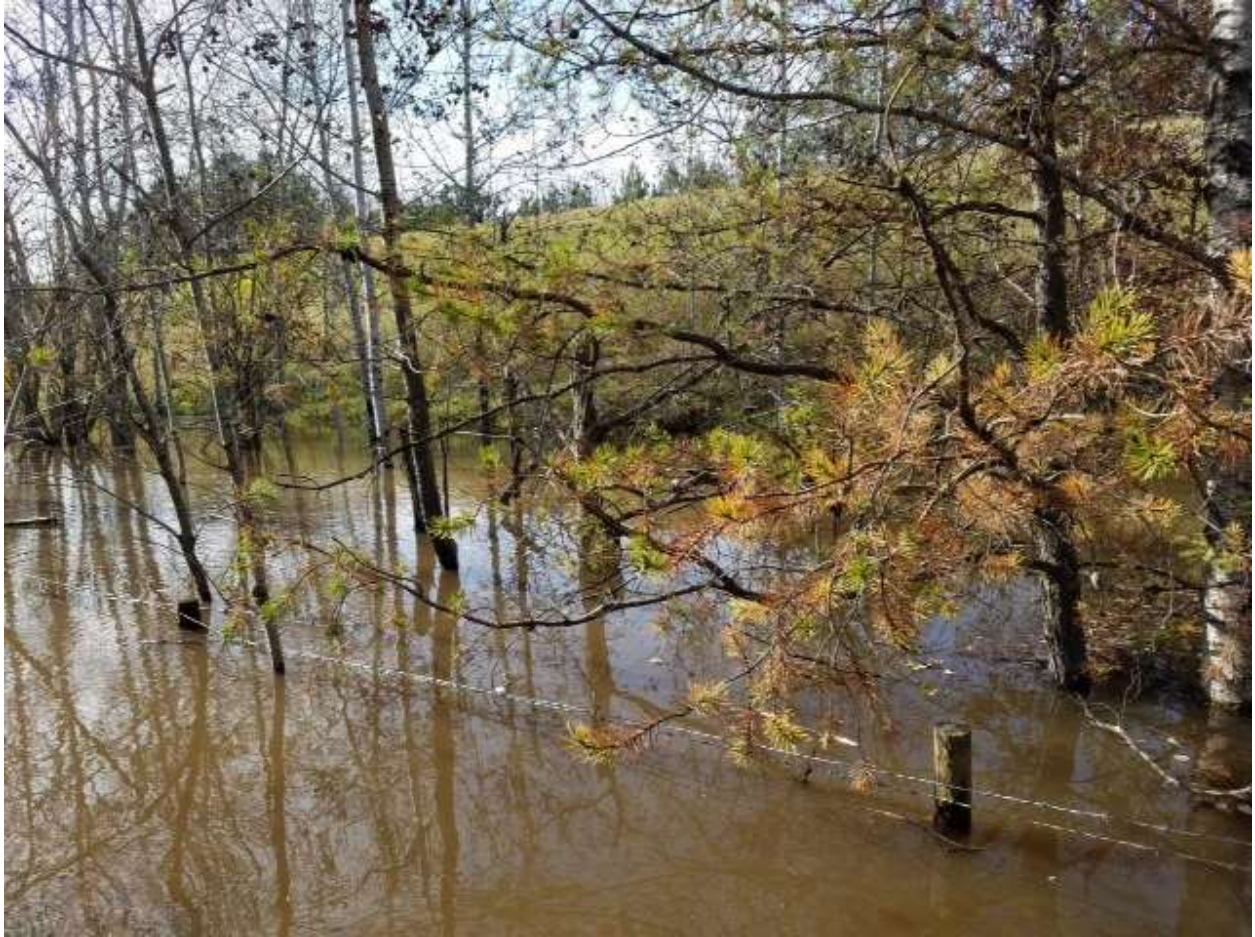
Appendix D

Water from Dago Lake at I35
